U.S. Naval Hospital, Operating Building (Bldg.3)
Park Boulevard, Balboa Park
San Diego
San Diego County
California

HABS No. CA-1548-C

HISTORIC AMERICAN BUILDINGS SURVEY
ARCHITECTURAL DATA FORM

OPERATING BUILDING (BLDG 3)

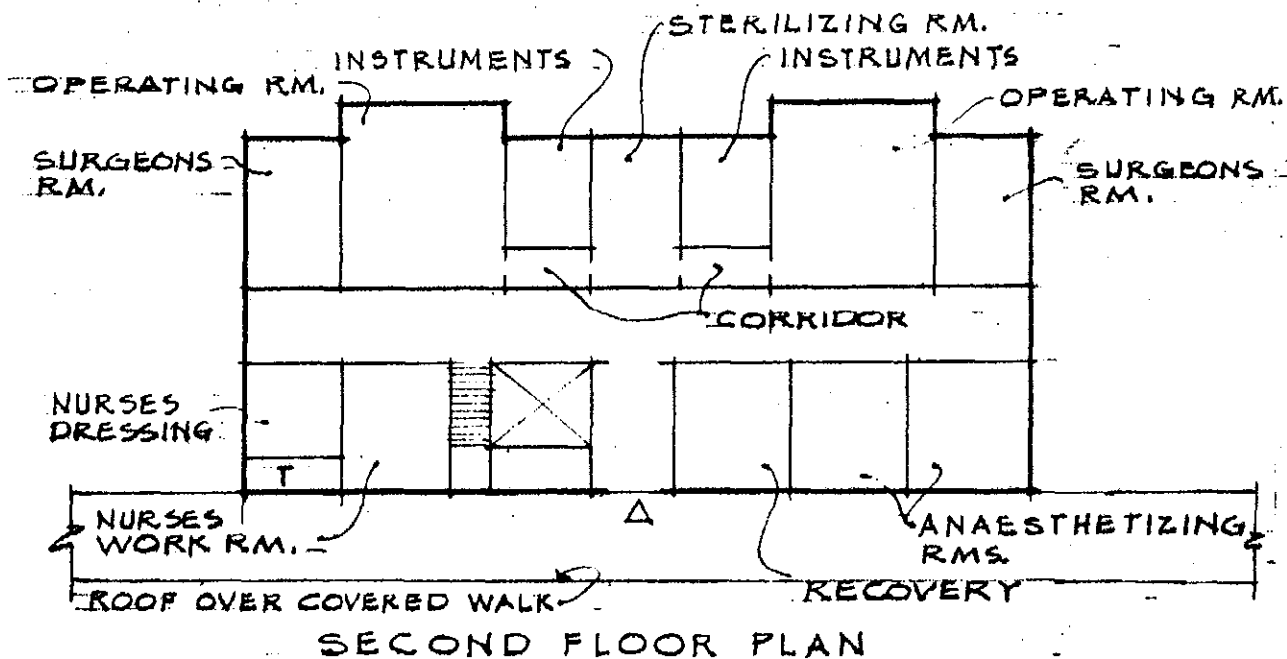
ORIGINAL FLOOR PLANS

STYLE: Mediterranean style. (Please see narrative for a discussion of the style.)		
MATERIAL AND STRUCTURAL SYSTEMS: Reinforced concrete frame and floors, hollow-tile-infilled walls, stucco exterior, wood roof framing, mission tile roof, and wood double-hung six-over-six windows, and metal-framed skylights. (Also see narrative and outline report concerning Building 1 for additional information on construction.)		
SHAPE AND DIMENSIONS OF STRUCTURE: (PLEASE SEE SKETCHED FLOOR PLAN ON SEPARATE PAGE)		
EXTERIOR FEATURES OF NOTE: (PLEASE SEE 1985 PHOTOGRAPHS.) Large north-facing windows and skylights at operating rooms. Connects to adjacent buildings by means of covered walks.		
INTERIOR FEATURES OF NOTE: (PLEASE SEE SKETCHED FLOOR PLAN ON SEPARATE PAGE) Operating Rooms. Original floors are terrazzo with coved terrazzo base.		
MAJOR ALTERATIONS AND ADDITIONS WITH DATES: Sketch of existing floorplan shows extent of major changes. Upper walkway enclosed in 1930's. Enlarged by adding an operating room on each end in 1942. Each new operating room has an observation gallery. Dropped ceilings with fluorescent lights. Sketch of existing floor plan shows extent of major changes.

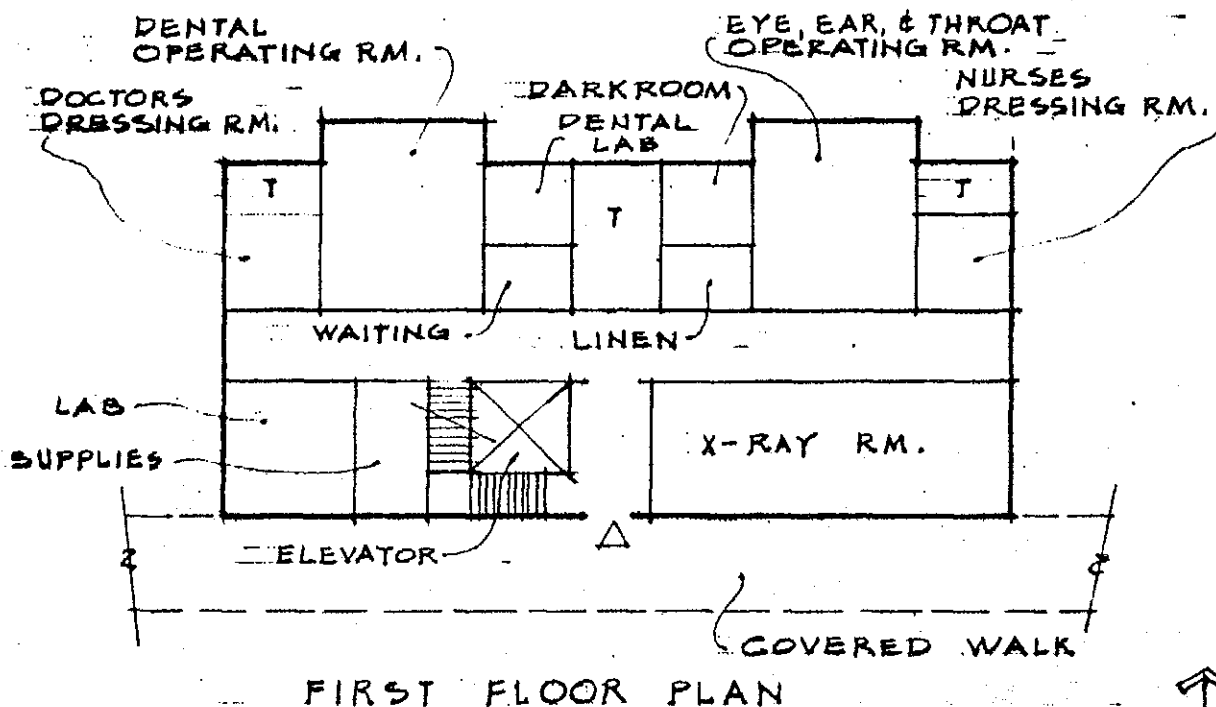
EXISTING FLOOR PLANS

PRESENT CONDITION AND USE: Adequately maintained with no eye to historic preservation. Exterior has had only minor changes other than additions. Current use is noted on existing floor plan.		
ADDITIONAL INFORMATION: This building separates the North and Central Court Yards. Connects by open walks to buildings on east and west.		
SOURCES OF INFORMATION: Original construction drawings; Architectural and Historical Resources Survey by Sally Woodbridge; and, field inspection.		
COMPILER, AFFILIATION: Joel Sharp, employee of Robert O. Ferris, A.I.A., Contractor to Dept. of the Navy, Western Division, Naval Facilities Engineering Command, San Bruno, Calif.		DATE: December 1985

AIR CONDITIONING EQUIP. 1953

UPPER CORRIDOR ENCLOSED 1942
